Report for NERA-NDRI

Monitoring localised corrosion behaviour of decommissioned O & G metallic infrastructure in the ocean

15 July 2022

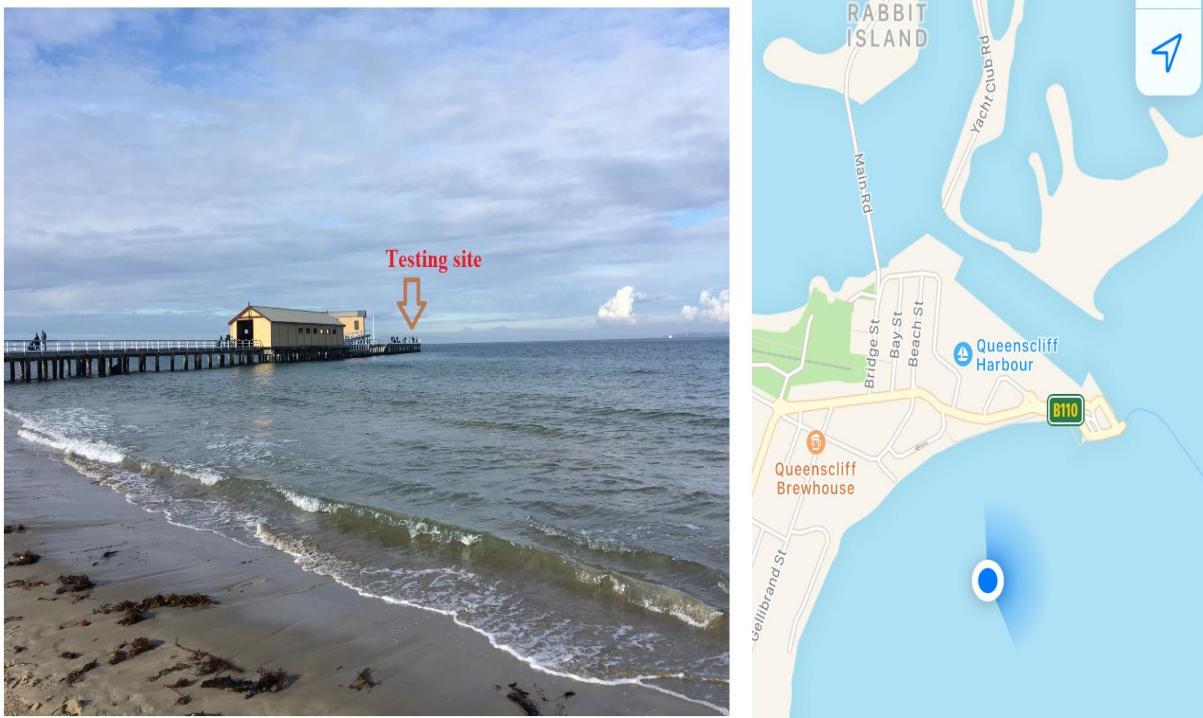
(a). Field test locations at Queenscliff

(b). Field test setup at Queenscliff and measurement at the Queenscliff field testing site.

Figure 2. Field test locations and field testing setup and measurements at Queenscliff field testing site for acquiring localised corrosion data.

The electrode array probes were used for continuous field in-situ electrochemical monitoring, to obtain information about the initiation, propagation and mechanism of localised forms of metal corrosion, under simulated decommissioned oil and gas infrastructure conditions. The field corrosion monitoring tests were conducted by exposing corrosion probes in a marine environment laboratory at Deakin University; at the Deakin Centre for Marine Fisheries and Aquaculture Sciences at Queenscliff (Vic.) and at the University of Newcastle Taylors Beach (NSW) field test site. Figure 2 shows the field test locations and the field testing setup and measurements at the Queenscliff field testing site. Figure 3 shows the field testing setup and measurements at the Taylors Beach field testing site.

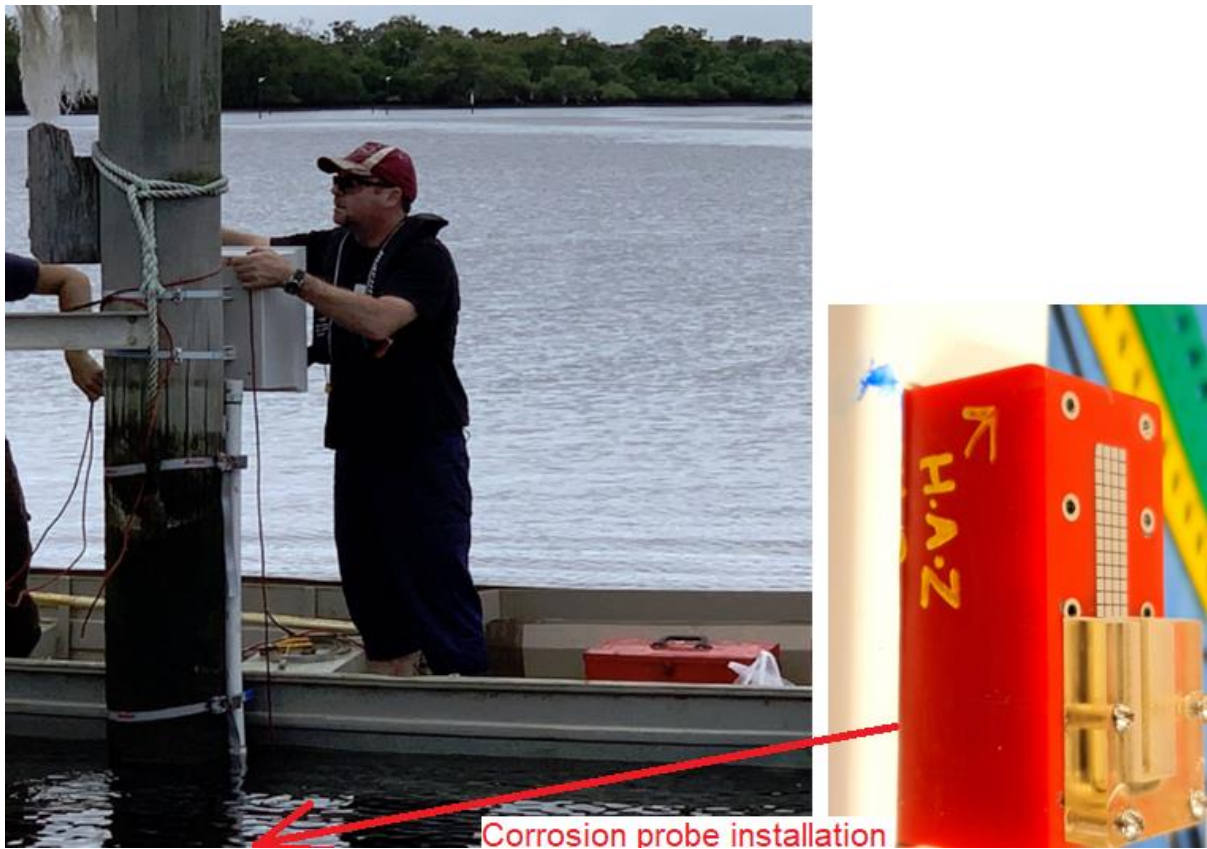
Figure 3. Field test locations and field testing setup and measurements at Taylor's Beach NSW field testing site for acquiring localised corrosion data.

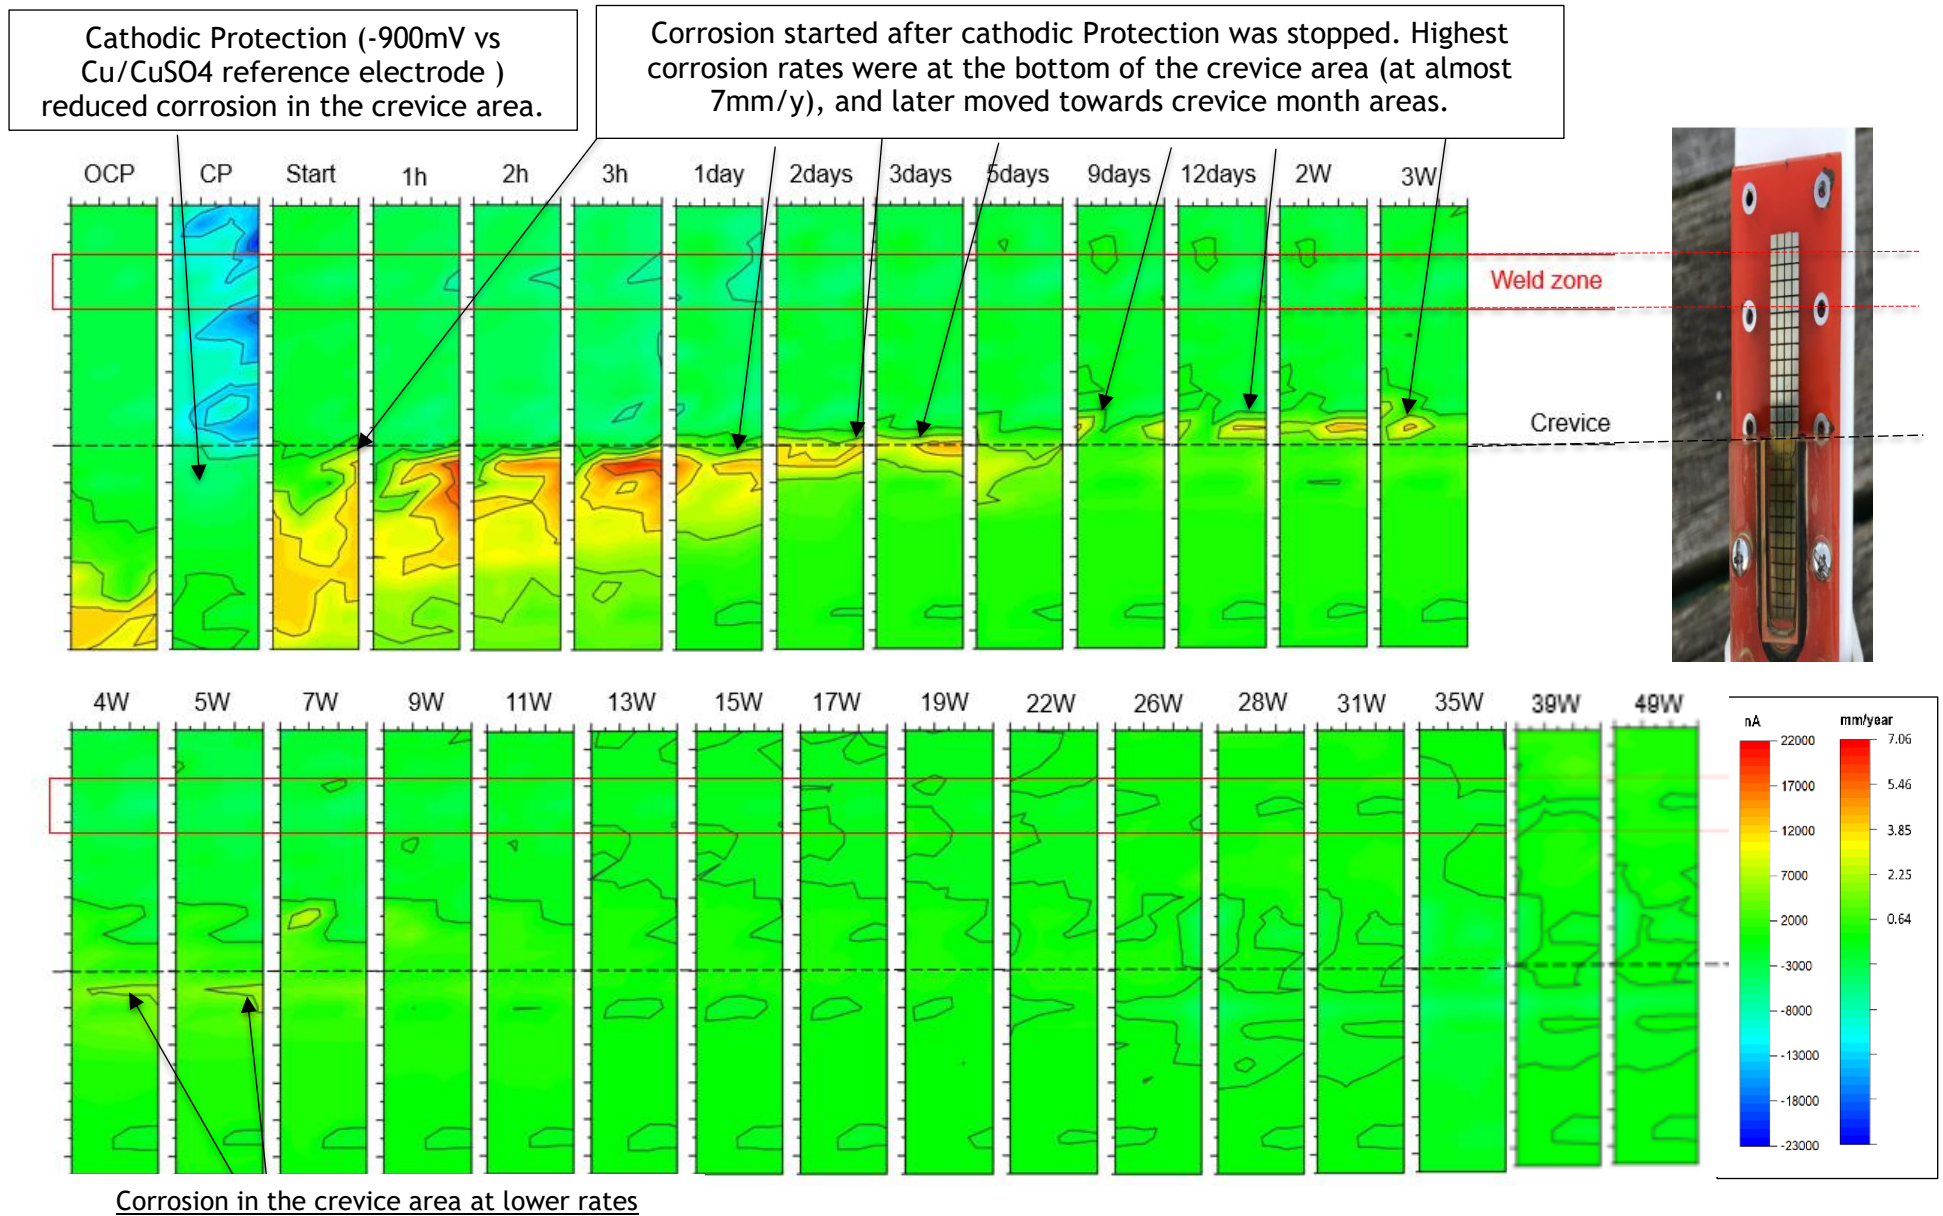
Figure 4(a). Queenscliff site long-term measurement data (showing corrosion rates in the same scale).

Corrosion started to be active at heat affected zone (as anode) with weldment as cathode.

Figure 4(a) shows the corrosion measurement data obtained from the field-testing at the Queenscliff site. These are all at the same comparative scale. The longer term data (weeks 11-35) is shown in Figure 4(b) at a magnified scale in order to increase the visibility of weldment corrosion and cathodic activities inside the crevice area. Throughout, the corrosion currents (in μA) measured within and outside the crevice zone were translated to corrosion rates (in mm/y) based on using Faraday's law. The calculated corrosion rates are represented by colour coding in Figures 4(a) and (b). Evidently, for practical applications the highest corrosion rates within the crevice zone (or outside it) are of most interest because they indicate the worst case scenario damages to marine structures and that could be

From Figure 4(a) it can be seen that at the very beginning of field exposure, corrosion initiated on the probe surface mainly within the crevice area. When cathodic protection (at -900mV vs Cu/CuSO₄ reference electrode) was applied, the corrosion in the crevice area reduced to almost zero. However, corrosion started again after the cathodic protection potential was switched off. In the first week the highest corrosion rates were observed at the bottom of the crevice area, at approximately 7mm/y, and later moved towards crevice mouth area. Corrosion was concentrated mainly at the crevice and at crevice-mouth areas. These observations are in agreement with industry experience that high crevice corrosion tends to occur at bolts (heads and washers) on flanges between spools, and between flanges bolted together, and at end plates on parked pipelines in ocean. In Figure 4(b), it can be seen that corrosion started to be active first at the heat-affected zone (i.e. acting as an anode with, presumably the rest of the weldment acting as the cathode). Figure 4(b) also shows that localised corrosion is visible at the heat-affected zone after 17 weeks and that major localised corrosion had occurred the same zone after 26 weeks. This is in agreement with earlier work on the corrosion of welds^{6,7}. Observation of the probe surface using an underwater camera showed that already after 35 weeks the crevice area was covered with corrosion products and marine growth, possibly causing separation of corrosion cells inside and outside the crevice.

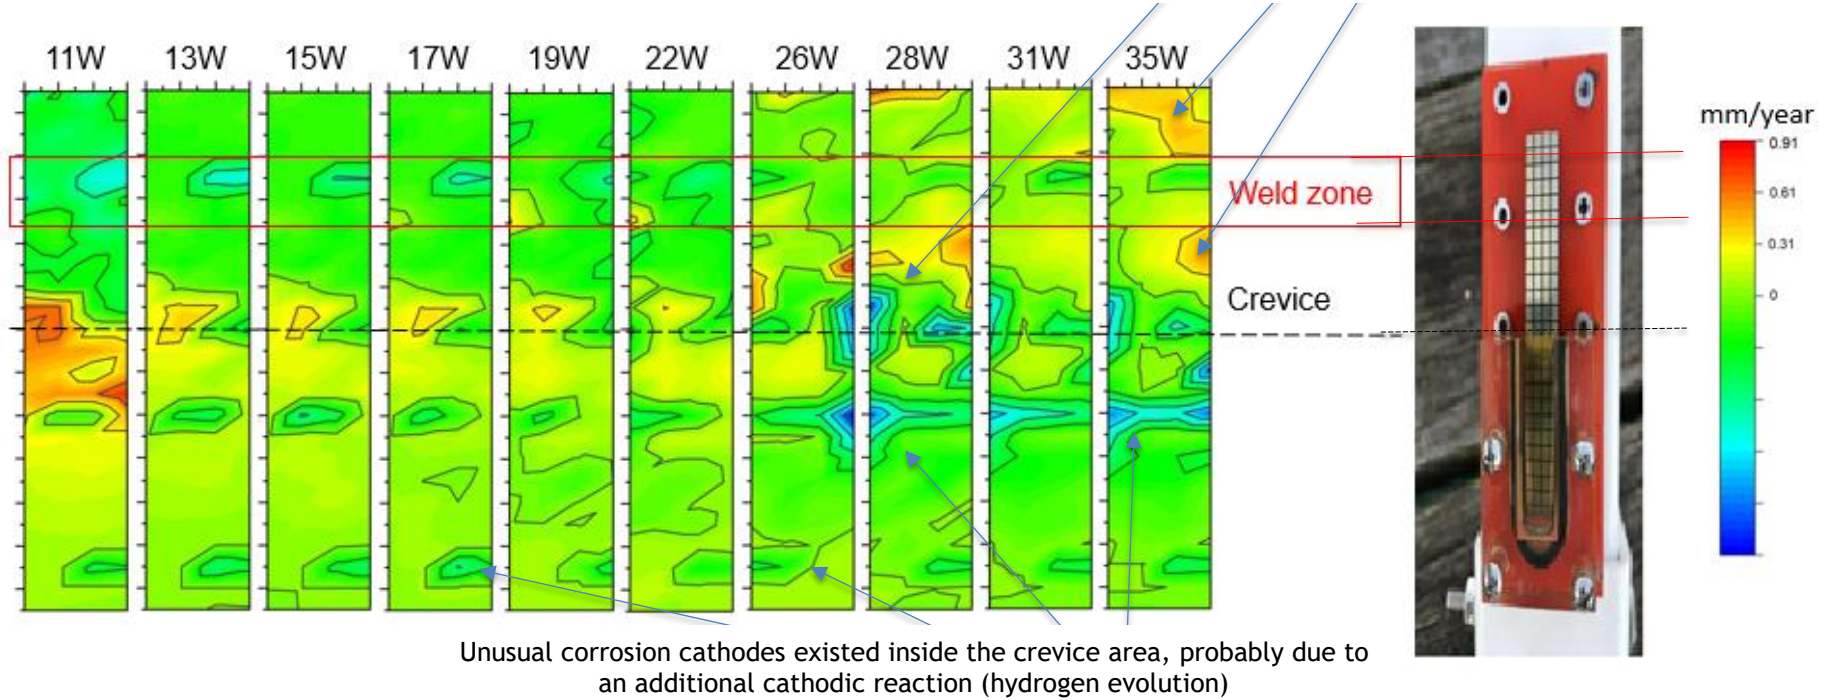
Figure 4(b). Queenscliff site long-term measurement data (showing details of corrosion rates in a different scale)

Corrosion started to be active at heat affected zone (as anode) with weldment as cathode.

In Figure 4(b), it is interesting to note the presence of corrosion inside the crevice area. Since the crevice area was covered with corrosion products and marine growth it would be expected that access of oxygen to the inside of the crevice would be limited. However, it is possible that the additional cathodic reaction associated with the observed corrosion is associated with the reduction in local pH (acidification) within the crevice and the development of corrosion with hydrogen evolution reaction as the cathodic reaction. This is in agreement with a theory proposed earlier⁸ and further shown in detail in recent research results⁹ for extended corrosion under corrosion deposits.

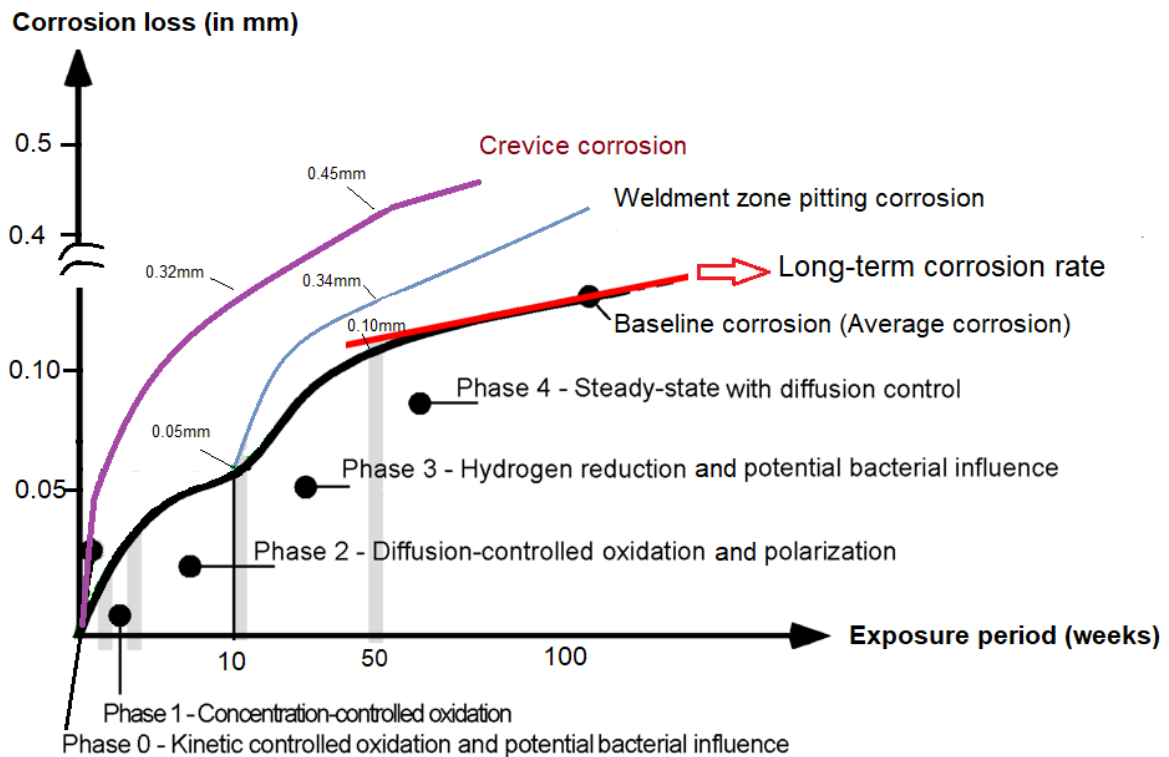
Figure 6. Localised corrosion trends diagram prepared based on the bi-modal corrosion loss model ^{1,2} using corrosion-monitoring data obtained at Queenscliff beach (see Tabel 1 below) by adding additional trend lines to indicate long-term corrosion loss and localised corrosion under the effects of crevice corrosion, weldment pitting corrosion.

Figures 6 and 7 are diagrams developed to predict localised corrosion based on the application of the bi-modal corrosion loss model ^{1,2} and in situ field corrosion monitoring data acquired as outlined above. The diagrams take the most common forms of localised corrosion (crevice and weldment pitting corrosion) into consideration by adding additional trend lines to the bi-modal corrosion loss model ^{1,2} to indicate localised corrosion loss with time. Figure 6 shows overall, crevice and weldment pitting corrosion trends at Queenscliff (average water temperature 13.7°C). The trends in this diagram are more closely relevant to south part of Australian climate conditions such as the Bass Strait, although at depth the water temperature will be considerably lower. Figure 7 shows overall, crevice and weldment pitting corrosion trends at Taylors Beach (average water temperature approximately 20°C). This diagram is more closely relevant to waters such as the Perth Basin. Tables 1 and 2 show the corrosion data used for plotting Figures 6 and 7, which are extracted from corrosion monitoring data shown in Figures 4 and 5.

Figures 6 and 7 will assist in estimation of localized corrosion in the early stages of corrosion exposure for decommissioned marine structures. For instance, for offshore Bass Strait locations, Figure 6 indicates expected crevice corrosion penetration of approximately 0.45mm over the first year. This would apply wherever crevice corrosion could occur, such as at bolts (heads, butts, washers) on flanges between spools, and between flanges bolted together, and at end plates on parked pipelines. Similarly, pitting corrosion penetration of approximately 0.34mm is predicted over the first year in heat-affected zones of welds. Over the same period, as shown in Figure 6, only 0.10mm of general corrosion (i.e. depth of penetration) can be expected over the pipe surface if unprotected. These results suggest that localised corrosion penetration can be 3-5 times greater than general corrosion, at least for such short periods of exposure. Importantly, since the trends are highly non-linear, it cannot be concluded that *rates* of corrosion differ by such amounts. As is evident, there is no such thing as a 'corrosion rate' for non-linear trends as in Figures 6 and 7. Note Figures 6 and 7 show only preliminary trends using the relatively short-term monitoring data. An updated version of this report will provide additional data being collected and also up-dated trends.

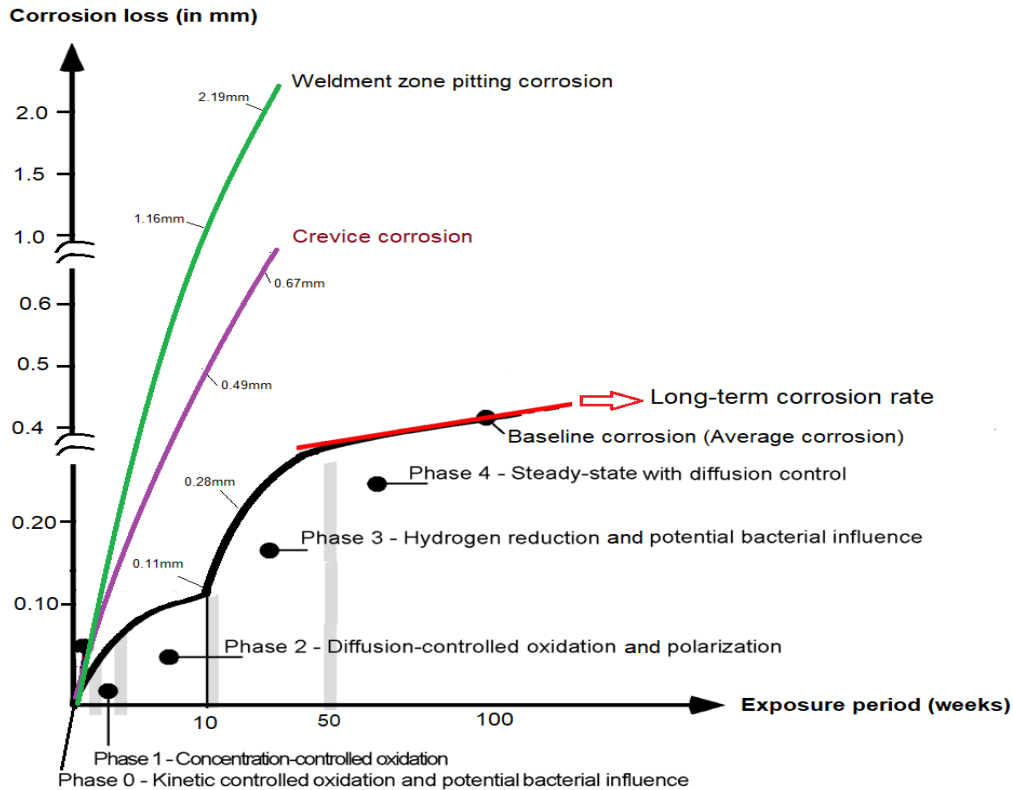
Figure 7. Localised corrosion trends diagram prepared based on the bi-modal corrosion loss model ^{1,2} using corrosion-monitoring data obtained at Taylors Beach (see Table 2) by adding additional trend lines to indicate long-term corrosion loss and localised corrosion under the effects of crevice corrosion, weldment pitting corrosion.

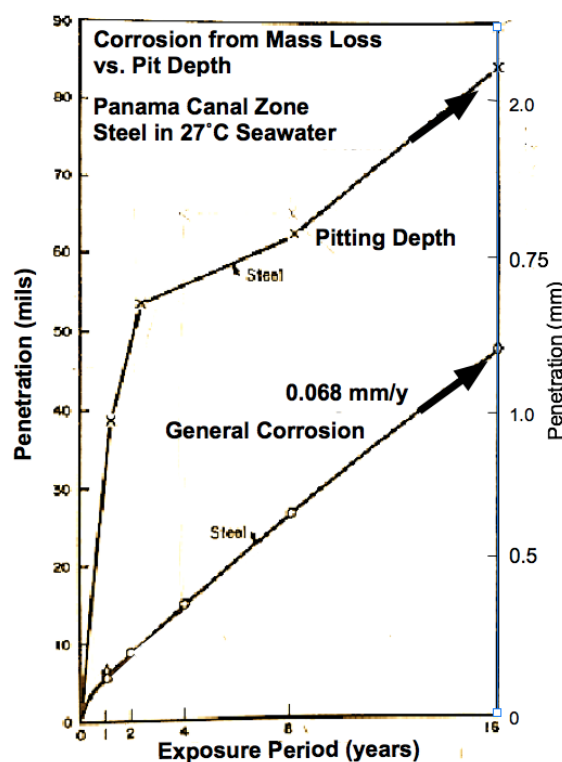
Figure 8. Plots of pit depth and of average depth of general corrosion of steel over 16 years of seawater exposure in the 27°C seawaters of the Panama Canal Zone (1 mils = 0.0254mm), showing the relationship (arrows added) between the two for extended exposures. Basic plots from Schumacher⁸. More details can be found in reference¹⁰.

A comparison of localised corrosion trending, such as in Figure 6, with trending over 16 years exposure for general corrosion penetration is shown in Figure 8, in this case for pit depth and general corrosion for steel exposed in the warmer waters of the Panama Canal Zone (27°C average). It is shown that localised corrosion penetration is approximately 0.5mm over over the first year while the general corrosion penetration is approximately 0.12mm.
